# Manhole Inspection Summary

Manhole # S33GG1007MH

**Location** Address: **3941 CLOVER HILL RD**

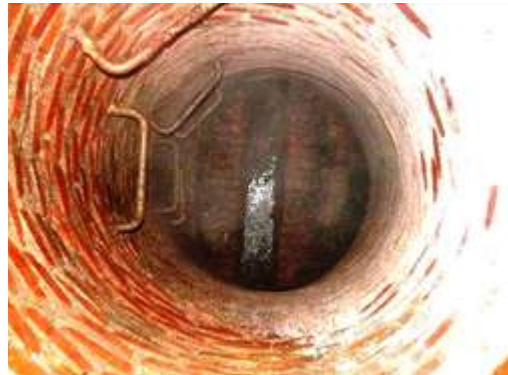
Top View

☐ Parged ☒ **Debris** (not Condition related)

**Surcharge** ☒ **Evidence Of Surcharge** Depth: **1** (ft.) ☐ Active Surcharge Present

Evidence of surcharge - Bench debris.

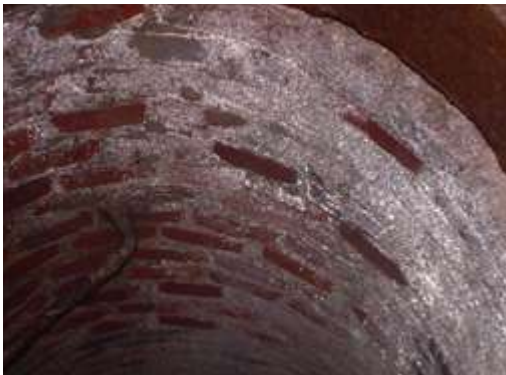
Defect

☒ **Leaks**

Infiltration: ☐ None ☒ **Joint** ☐ Cracks ☐ Mortar ☐ Roots ☒ **Wall**

Frame leaks. Corbel infiltration.
